Manhole Inspection Summary

Manhole # S15QQ1011MH

Insp Date: **11/20/06 10:27 AM**

Location Address: **4900 GREENSPRING AVE**

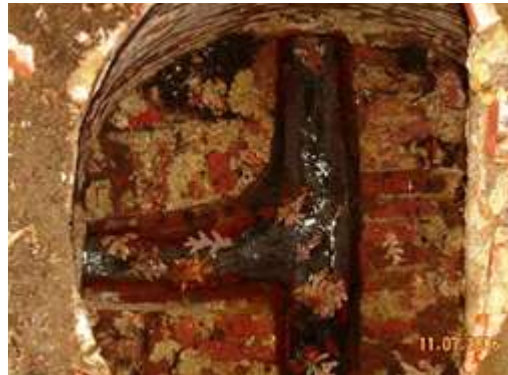
Top View

Adjustment deterioration, loose brick, and infiltration. Bench debris.

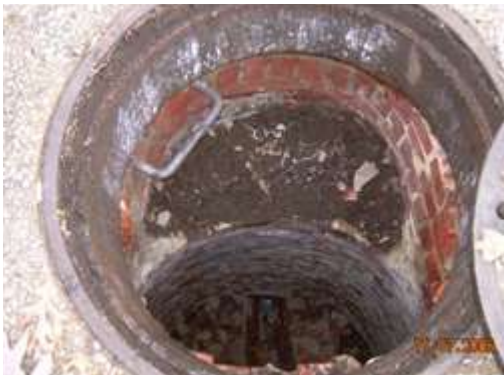
Defect

Frame leaks. Adjustment infiltration.

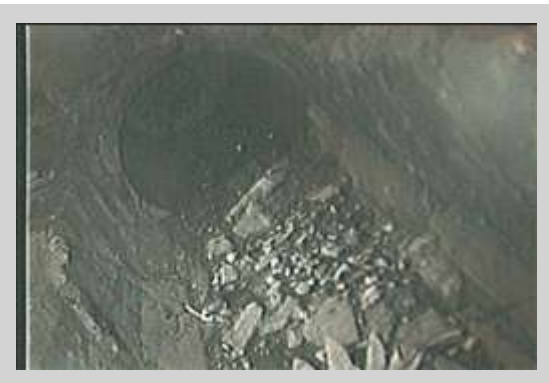
8 in. Circular Gravity Sewer Pipe In @ 6 O'Clock

Plugged.

Deposits: ☐ None ☒ **Mud** ☐ Sludge ☒ **Debris** ☐ Grease

Silt Depth: **2** (in.) Deposits Extent: **Medium**

Connects To: **Stub connection / abandoned**
